**Flood Control Project Maintenance
Levee Inspections**
LMA District Cover Sheet
Spring 2009 Levee Inspection Results

Reclamation District No. 2092

Spring 2009 Levee Inspection Results

Waterway		Bank	Unit Miles
Unit No. 01 San Joaquin River		Right	3.80

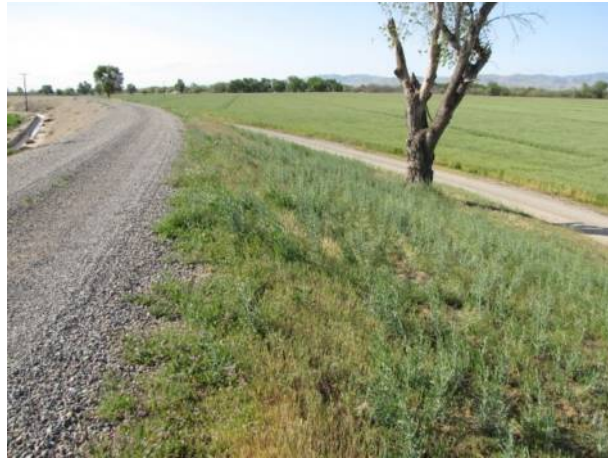
Levee Mile Report Line	2
Start Levee Mile	0.09
End Levee Mile	1.61
Location	Water Side
Category	Earthen Levee
Item	Vegetation

LMR Line	Levee Mile		Category	Item	Location *	Rating **	Action/Comment	GPS Latitude/Longitude		Photo	Issue
	Start	End						Start	End		
1	0.06	0.06	Earthen Levee	Encroachments	WS	C	Prunings	37.602518 ° -121.159136 °	37.602518 ° -121.159136 °		2
2	0.09	1.61	Earthen Levee	Vegetation	WS	M	Control annual grass and weeds on the levee slopes and easements.	37.602486 ° -121.159709 °	37.587244 ° -121.162699 °	Y	965
3	0.19	0.19	Interior Drainage & Piping Systems	Flap Gates	WS	M	Inspector Comments: Flap gate propped open, screw gate appears operational.	37.601999 ° -121.161290 °	37.601999 ° -121.161290 °		966
4	0.21	0.25	Earthen Levee	Vegetation	LS	M	Control annual grass and weeds on the levee slopes and easements.	37.601831 ° -121.161727 °	37.601648 ° -121.162453 °		967
5	0.21	0.26	Earthen Levee	Vegetation	LS	C	Remove the wild growth other than native grasses from the levee slopes.	37.601820 ° -121.161757 °	37.601626 ° -121.162485 °		3

Maintain all grass and brush at a height that does not obstruct visibility or the ability to conduct a flood fight.

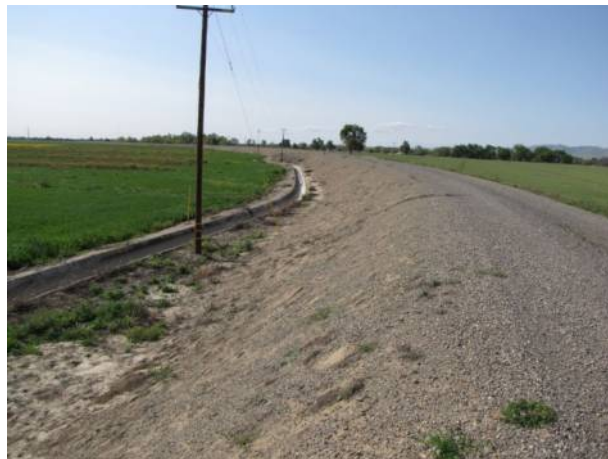
Levee Mile Report Line	7
Start Levee Mile	0.77
End Levee Mile	0.77
Location	Land Side
Category	Earthen Levee
Item	Vegetation

6	0.77	1.35	Earthen Levee	Encroachments	LS	PO	Agricultural Ditch	37.597291 ° -121.168496 °	° °		968
7	0.77	0.77	Earthen Levee	Vegetation	LS	A	Remove the wild growth other than native grasses from the levee slopes.	37.597290 ° -121.168494 °	37.597290 ° -121.168494 °	Y	969
8	1.55	1.69	Boat Survey	Boat Survey Erosion	LS	M	Inspector Comments: Not as serious - using lower rating	37.587130 ° -121.162830 °	° °		964
9	2.54	2.56	Earthen Levee	Vegetation	LS	C	Control annual grass and weeds on the levee slopes and easements.	37.578984 ° -121.156978 °	37.578829 ° -121.156981 °		4
10	2.76	2.76	Earthen Levee	Slope Stability	WS	C	Repair the levee slope damaged by vehicle traffic and prevent access where possible.	37.575885 ° -121.157218 °	37.575885 ° -121.157218 °		1

Example of good vegetation control on landward slope of levee at LM 0.77.
